Regarding:

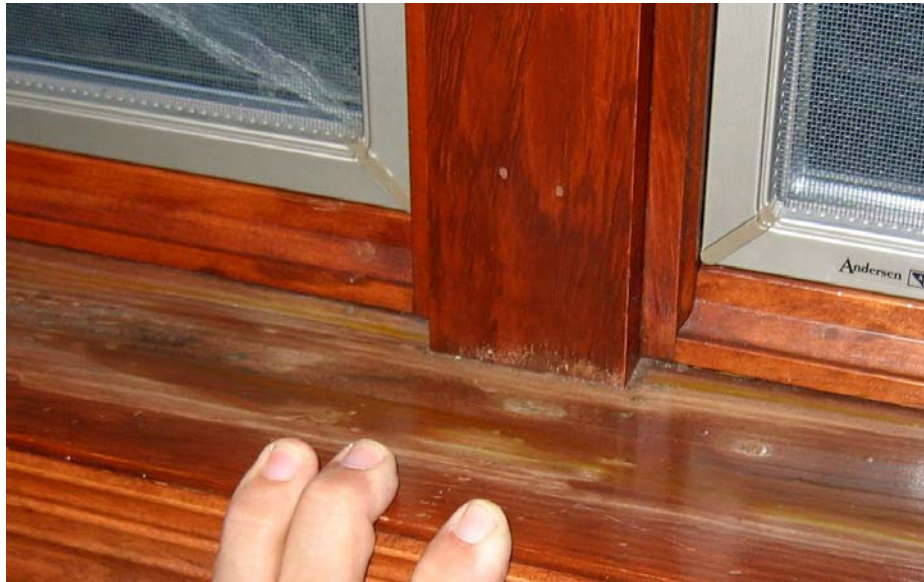
Photo - Window in study - office

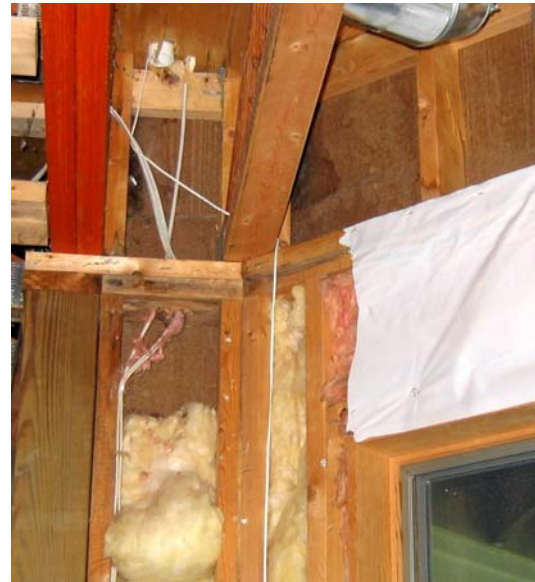
Photo - Rear wall water entry locations

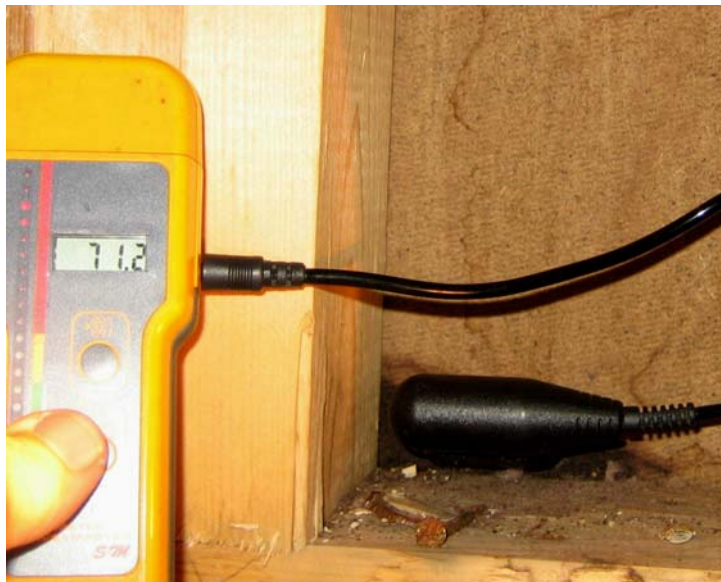
Photo - Moisture reading below dining room window

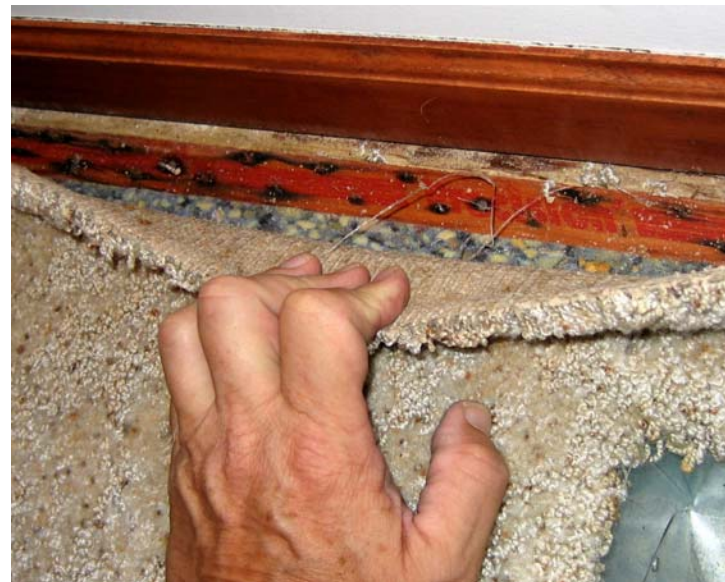
Photo - Study carpet tack strip

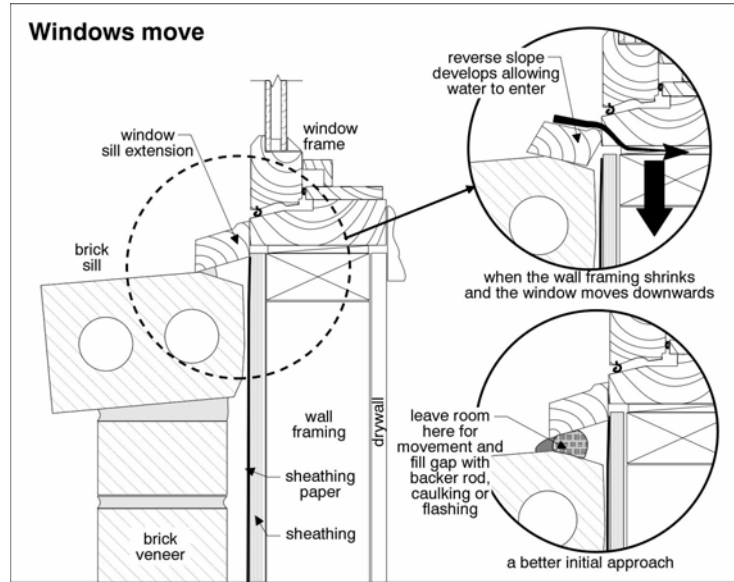
Drawing - Window movement

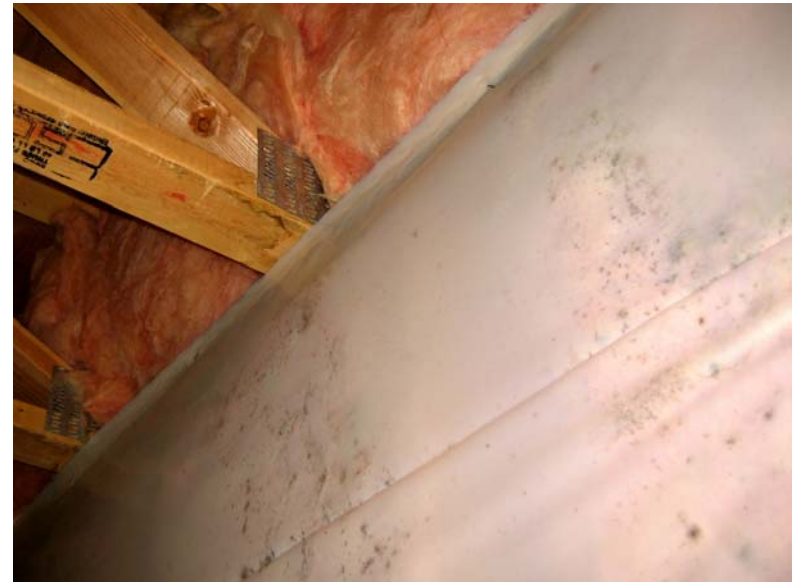
Photo - Rear wall plastic sheeting

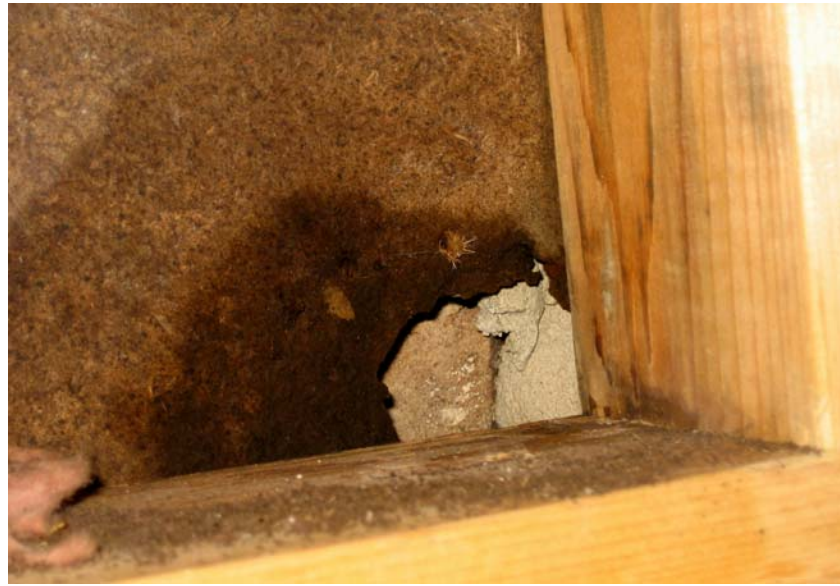
Photo - Hole in sheathing below dining room window.

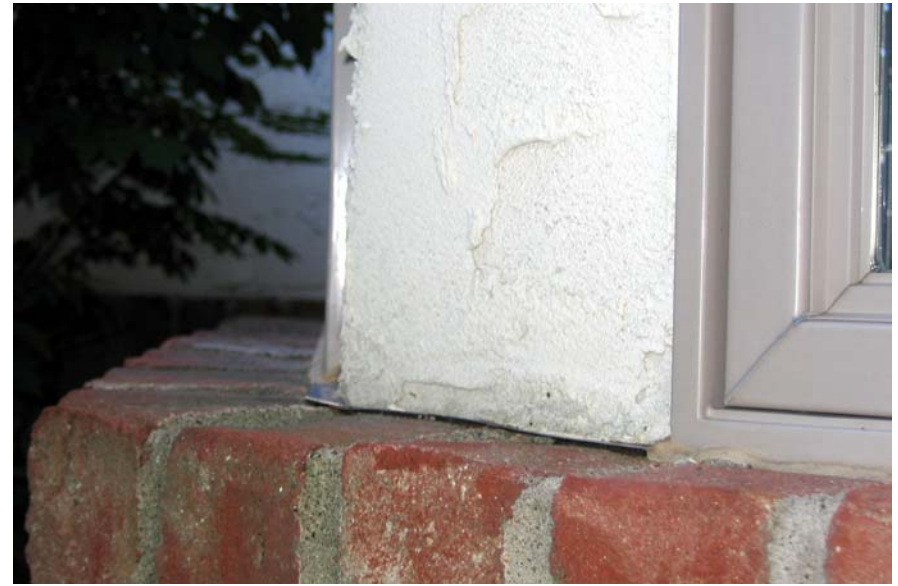
Photo - Dining room corner, caulk and flashing
